Asbestos and Limited Lead-Based Paint Survey Report

Clatsop County Courthouse
749 Commercial Street
Astoria, OR 97103

October 2006
Project #: 19786.001

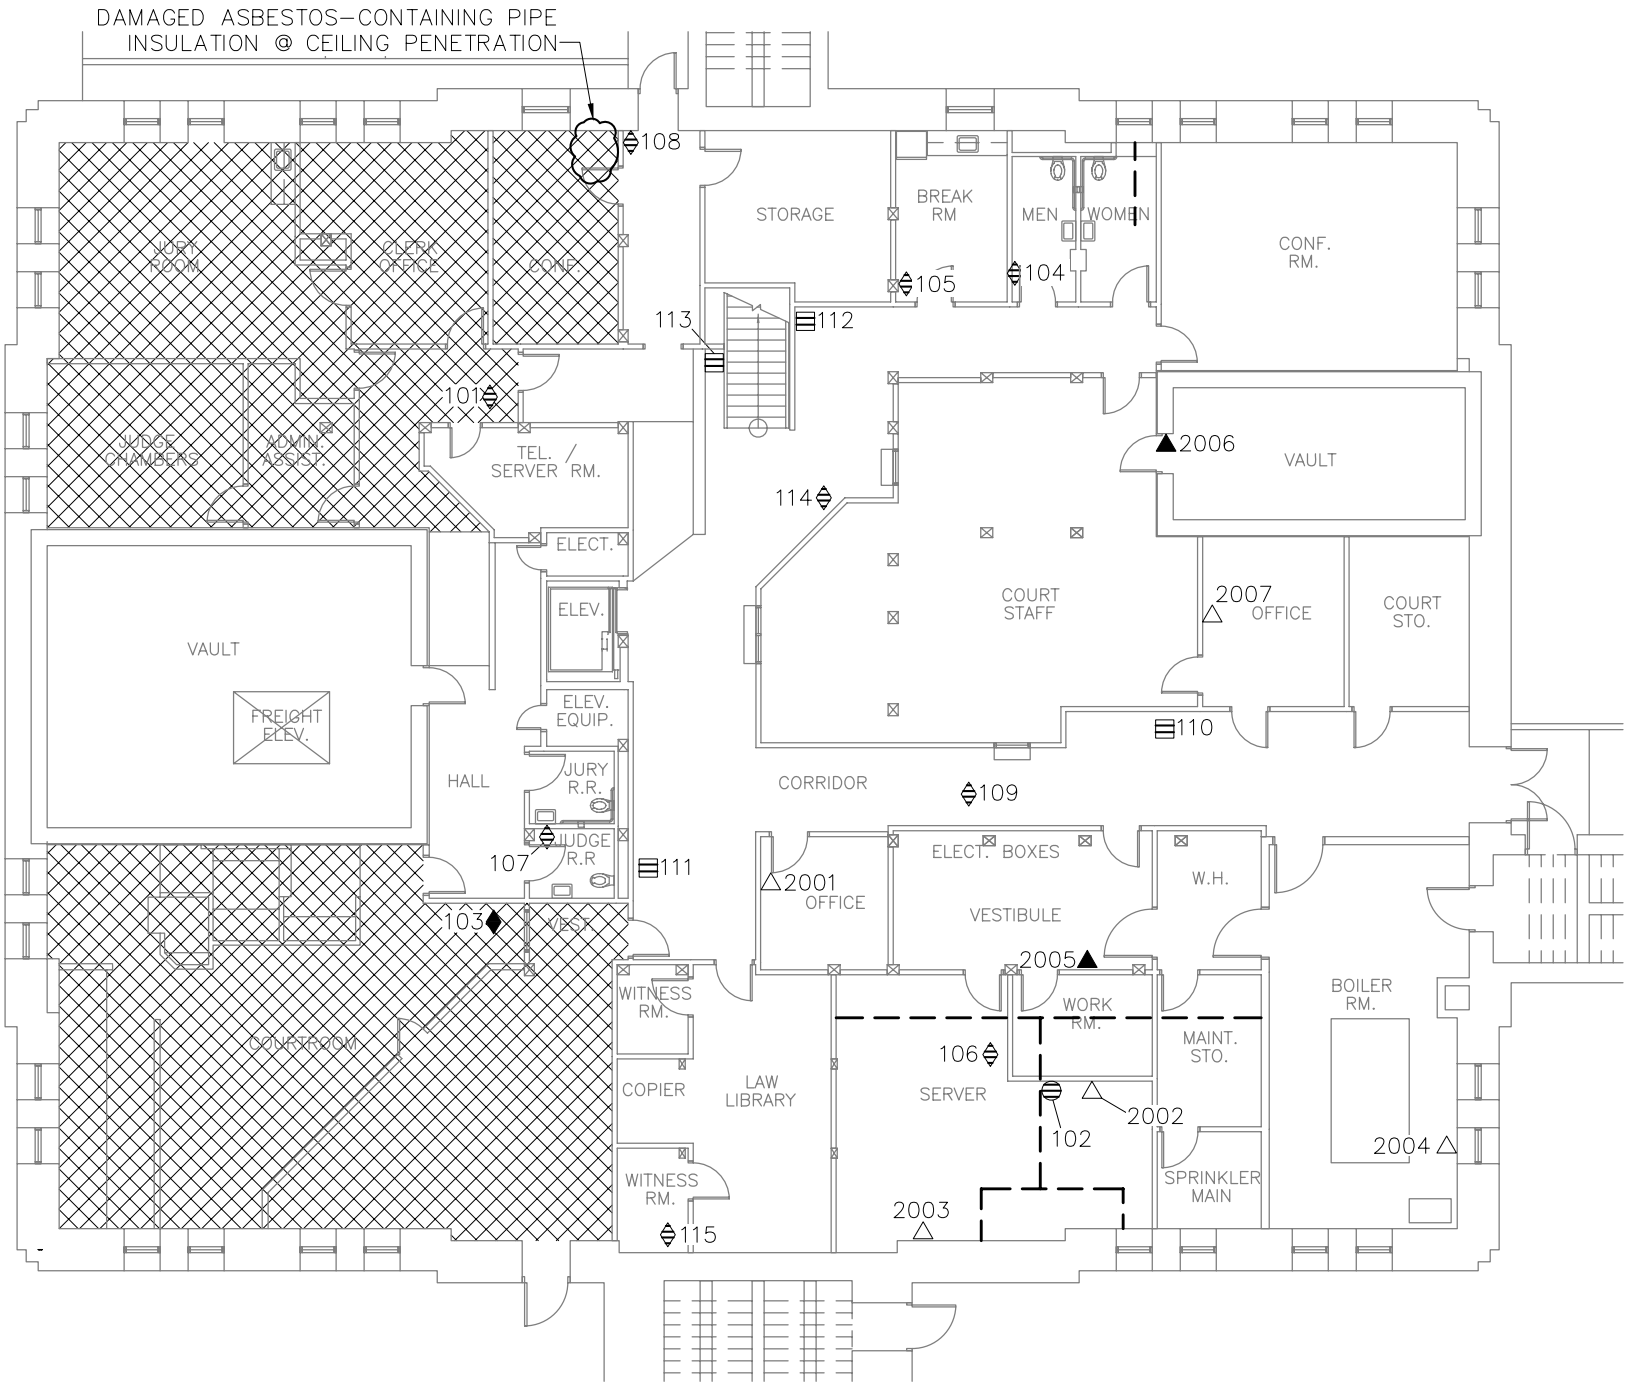
SAMPLE NUMBER	FIELD CODE	LAB RESULT (ppm)	MATERIAL DESCRIPTION
2001	19786.000-2001	<128 ppm	WALL; GYPSUM; OFF WHITE; GOOD
2002	19786.000-2002	<143 ppm	WALL; GYPSUM; CREAM; GOOD
2003	19786.000-2003	<102 ppm	WALL; BRICK; CREAM; GOOD
2004	19786.000-2004	<72.5 ppm	WALL; BRICK; WHITE; POOR
2005	19786.000-2005	132 ppm	COLUMN; WOOD; GREEN; FAIR
2006	19786.000-2006	33,500 ppm	VAULT; DOOR; METAL; YELLOW; GOOD
2007	19786.000-2007	<217 ppm	WALL; GYPSUM; OFF WHITE; GOOD

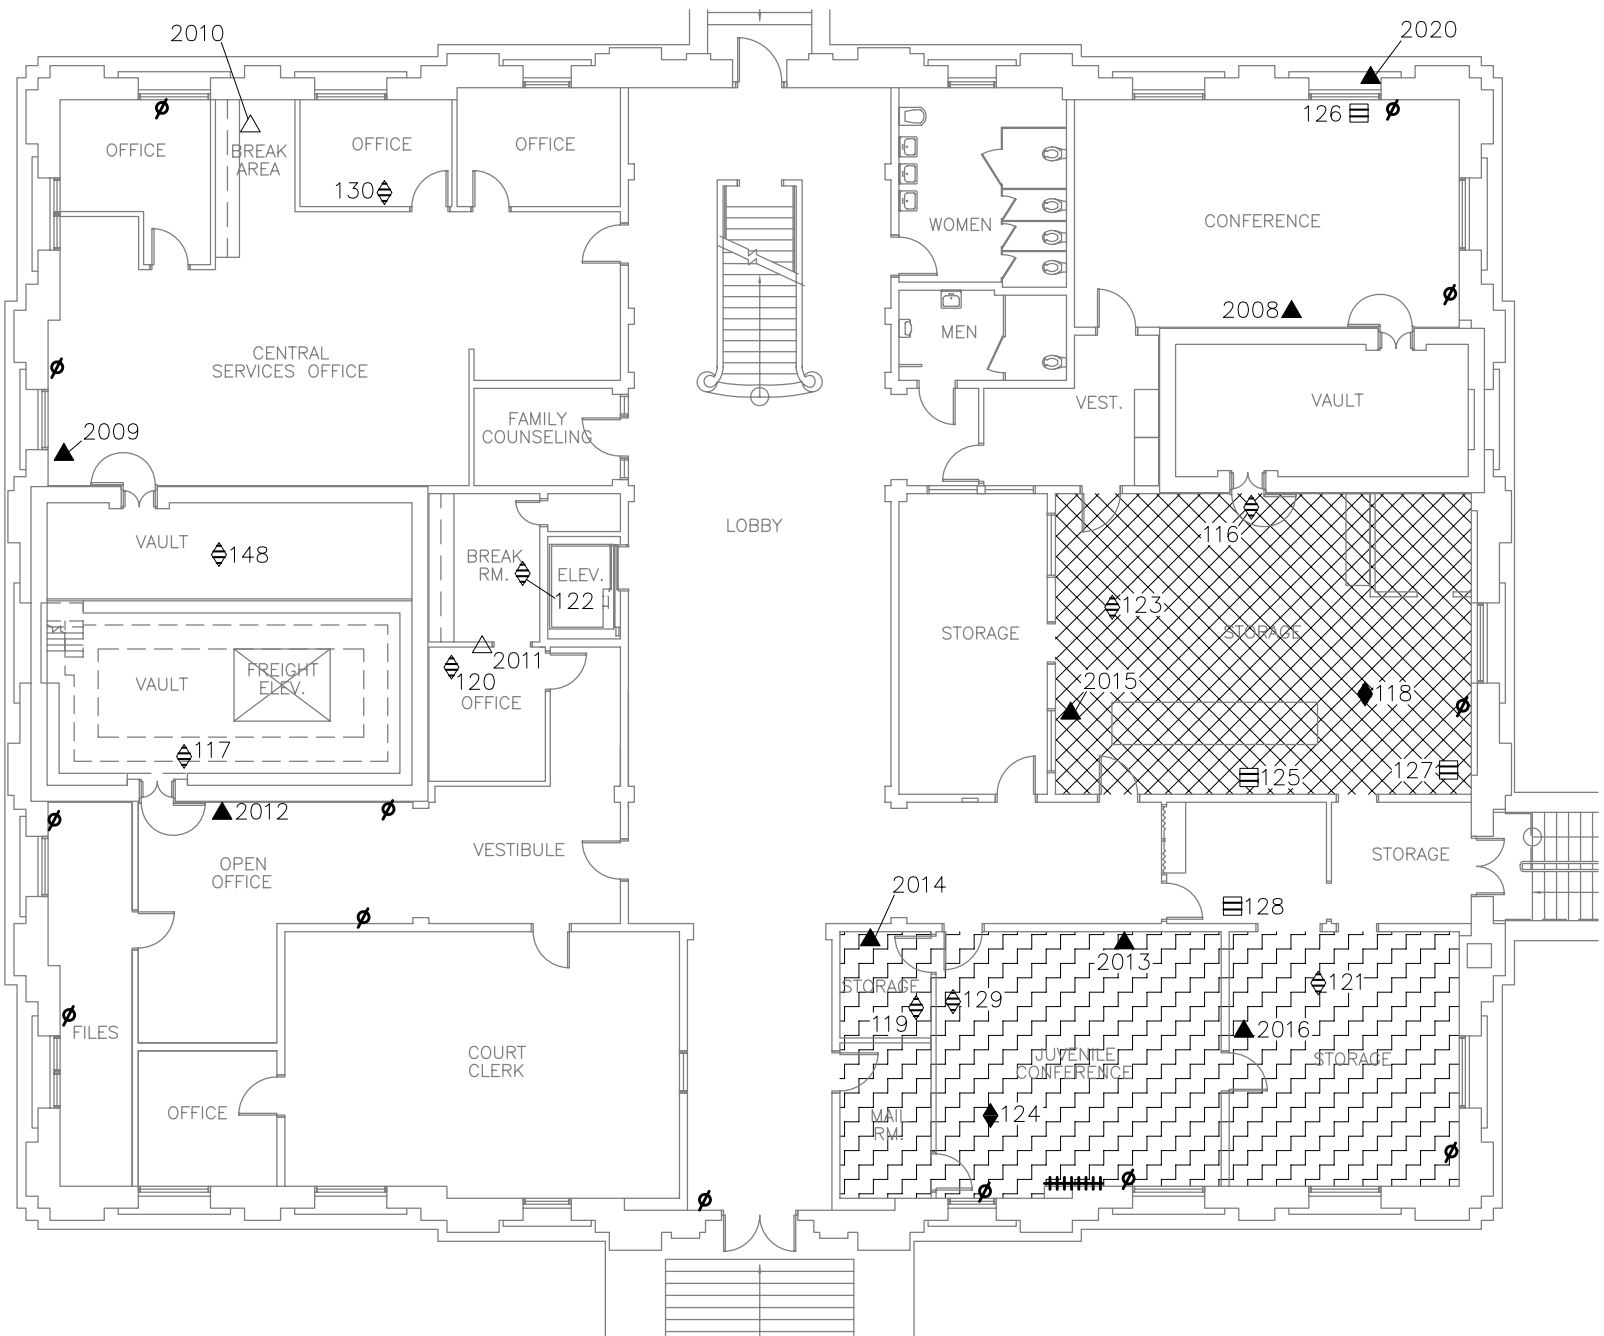
SAMPLE NUMBER	FIELD CODE	LAB RESULT (ppm)	MATERIAL DESCRIPTION
▲2008	19786.000-2008	127 ppm	WALL; PLASTER; WHITE/GREEN; GOOD
▲2009	19786.000-2009	165,000 ppm	WALL; PLASTER; WHITE/TAN; GOOD
△2010	19786.000-2010	<105 ppm	WALL; GYPSUM; WHITE; GOOD
△2011	19786.000-2011	<84.4 ppm	WALL; PLASTER; WHITE/TAN; GOOD
▲2012	19786.000-2012	141,000 ppm	WALL; PLASTER; WHITE/TAN; GOOD
▲2013	19786.000-2013	3190 ppm	WALL; PLASTER; GREEN/TAN; GOOD
▲2014	19786.000-2014	102 ppm	WALL; PLASTER; WHITE; GOOD
▲2015	19786.000-2015	1520 ppm	WALL; PLASTER; GREEN/TAN; GOOD
▲2016	19786.000-2016	4540 ppm	WALL; PLASTER; GREEN/TAN; GOOD
▲2020	19786.000-2020	110,000 ppm	WINDOW FRAME; WOOD; MAROON; GOOD

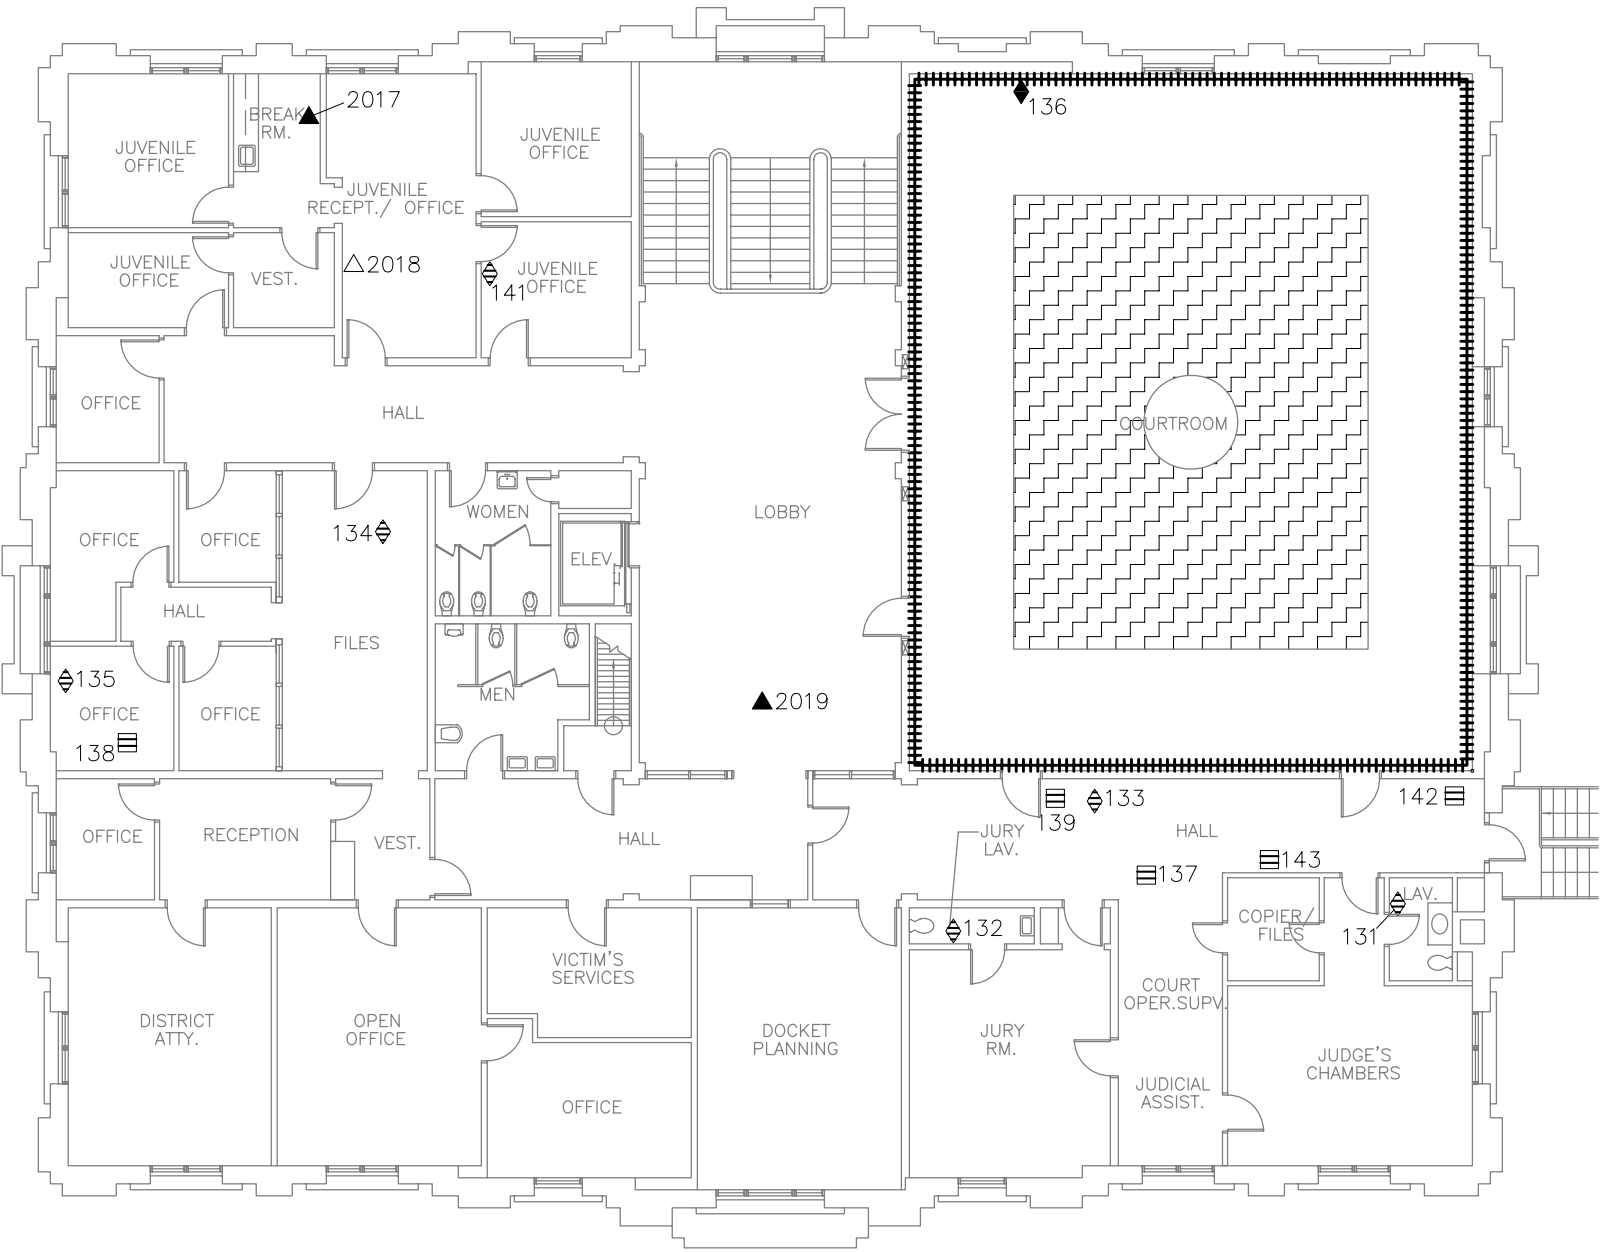
SAMPLE NUMBER	FIELD CODE	LAB RESULT (ppm)	MATERIAL DESCRIPTION
▲2017	19786.000-2017	226 ppm	WALL; PLASTER; WHITE/GREEN; GOOD
△2018	19786.000-2018	<128 ppm	WALL; WOOD; WHITE/GREEN; GOOD
▲2019	19786.000-2019	510 ppm	CEILING; PLASTER; WHITE/TAN; GOOD

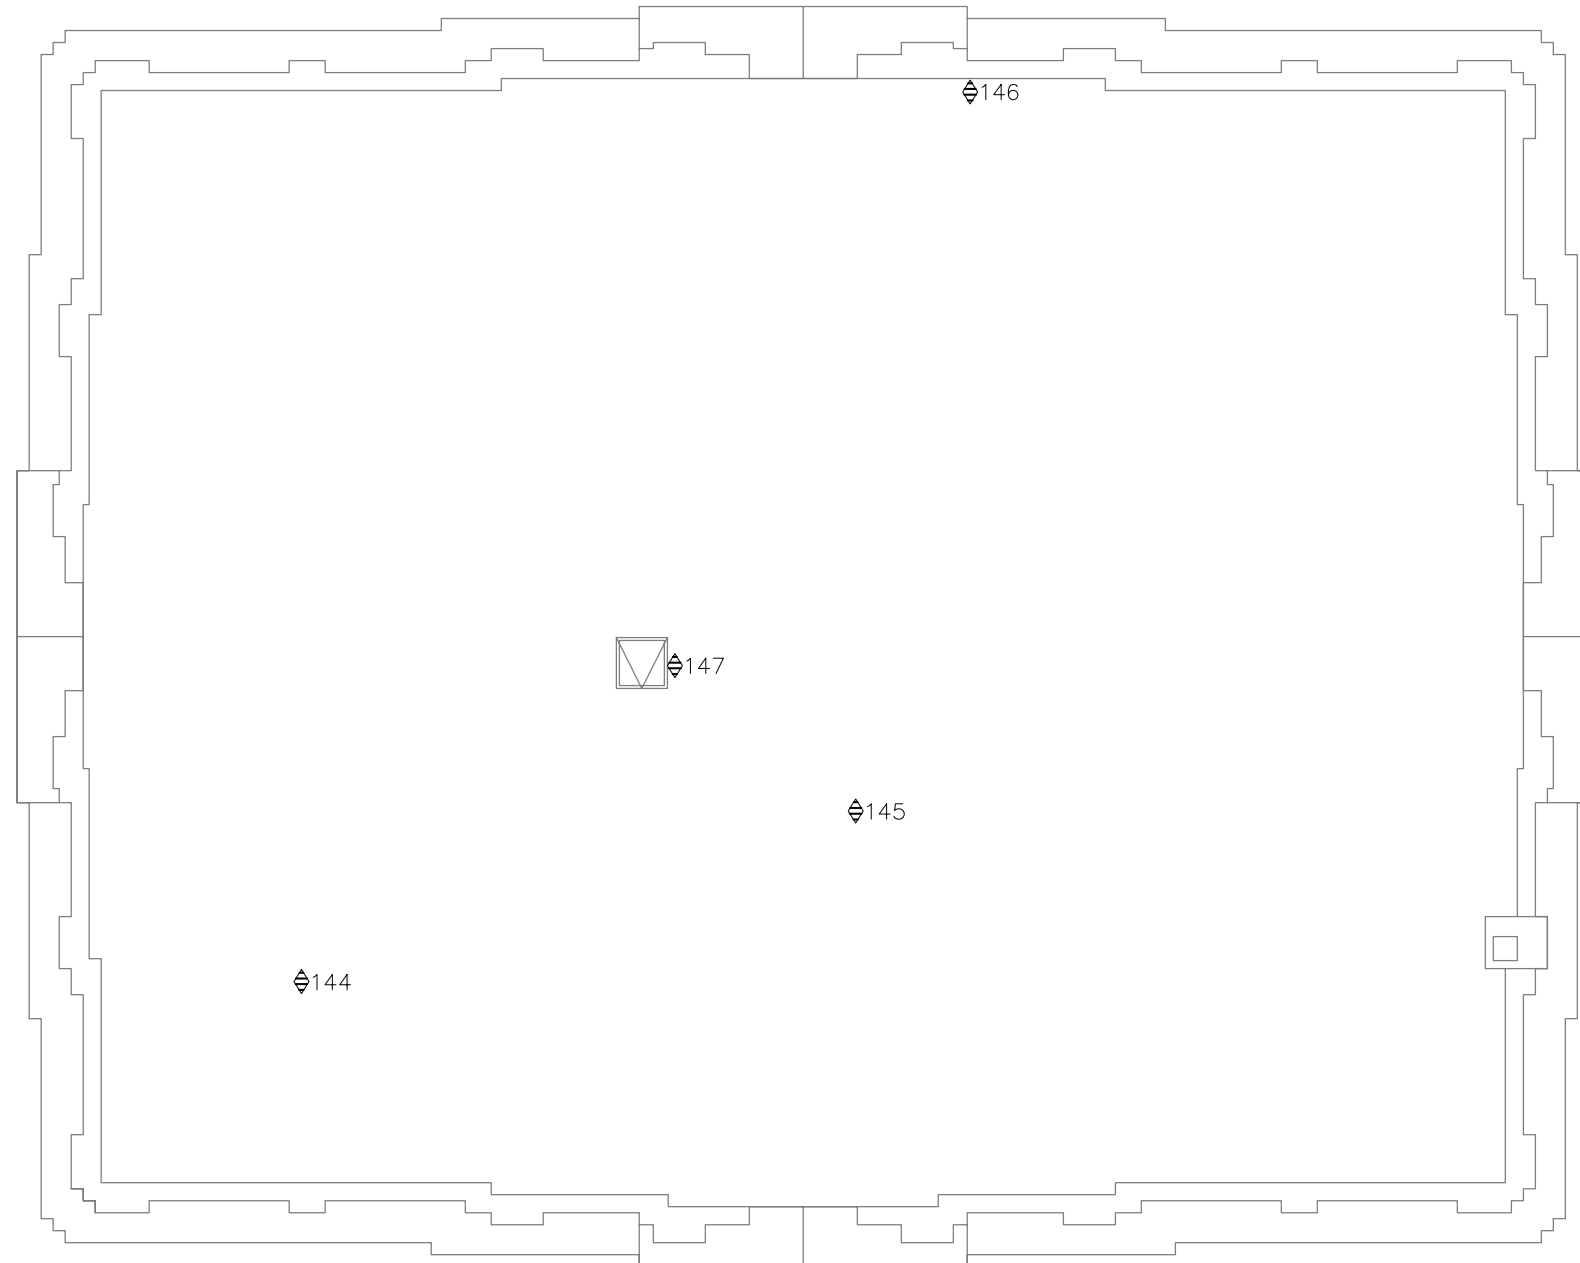
DRAWING REFERENCE	FIELD CODE	LAB RESULT	MATERIAL SAMPLED
§144	19786.000-144	(-/-)	BUILT-UP ROOFING (01)
§145	19786.000-145	(-/-)	BUILT-UP ROOFING (01)
§146	19786.000-146	(-)	BUILT-UP ROOFING (02)
§147	19786.000-147	(-)	BUILT-UP ROOFING (03)
