ELEVATOR MODERNIZATION REPORT

CLATSOP COUNTY, OR

FOUR (4) ELEVATORS

5/26/2021

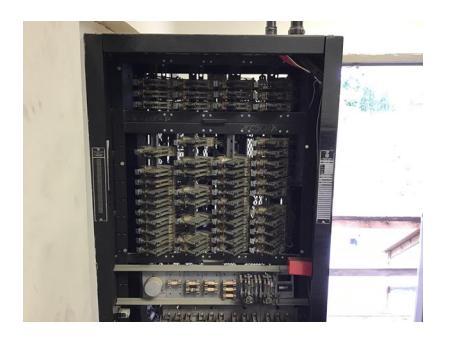
Fig. 1 – Controller

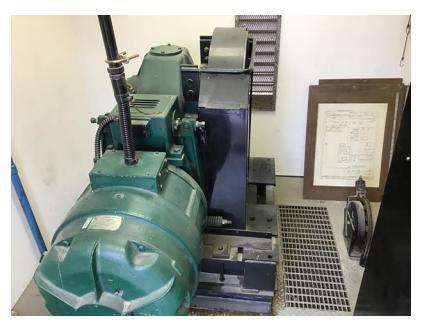
Fig. 2 – Hoist motor/machine

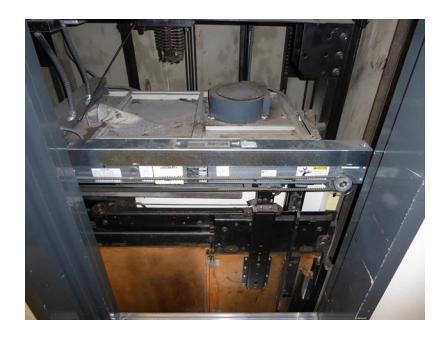
Fig. 5 – Door operator

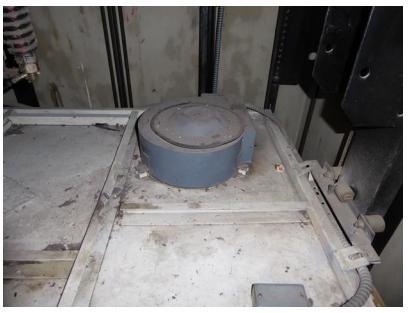
Fig. 8 – Cab fan

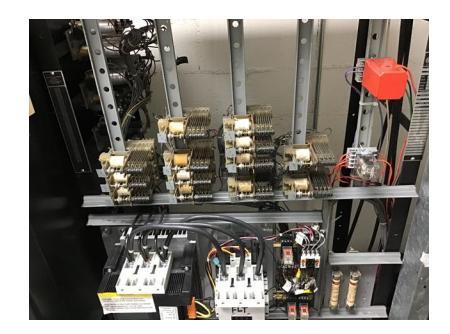
Fig. 1 – Controller

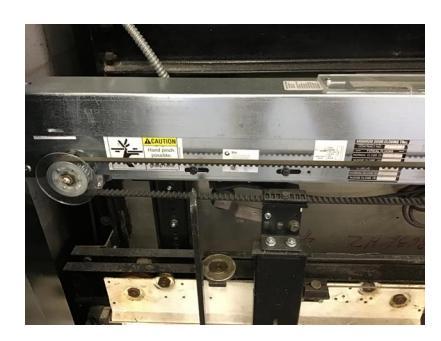
Fig. 5 – Newer door operator

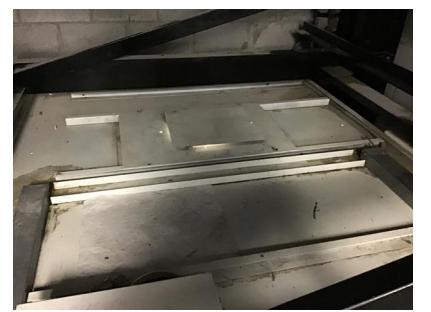
Car top and pit areas were clean. The cab does not have a ventilation fan, however there is a cutout for one and we recommend installing one now or during a future modernization to improve airflow in the cab.

Fig. 7 – Car top (incl. fan cutout)

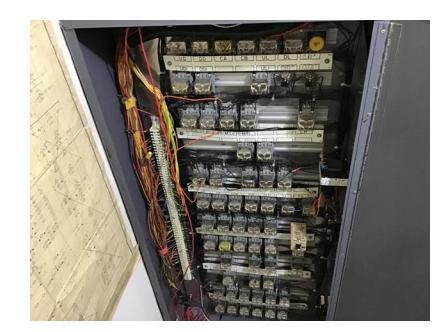
Fig. 1 – Controller

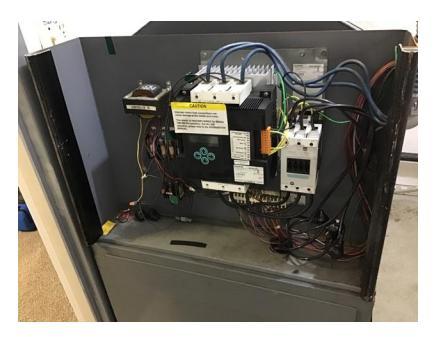
Fig. 2 – Newer solid-state "soft" starter

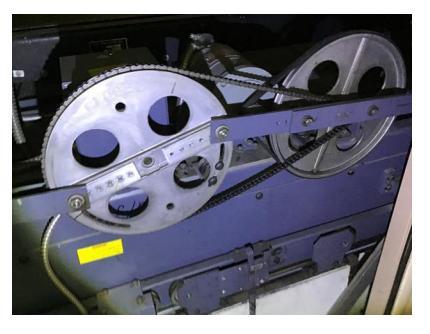
Fig. 6 – Door operator

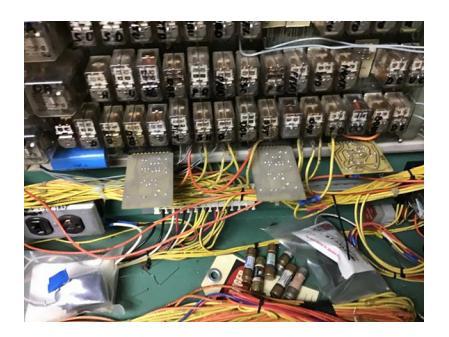
Fig. 1 – Controller

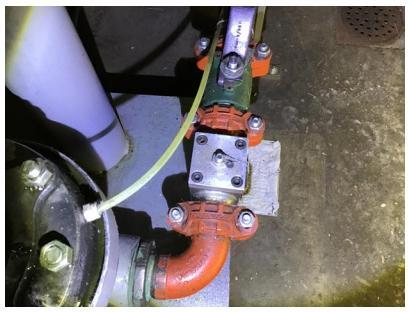
Fig. 9 – Seismic overspeed valve

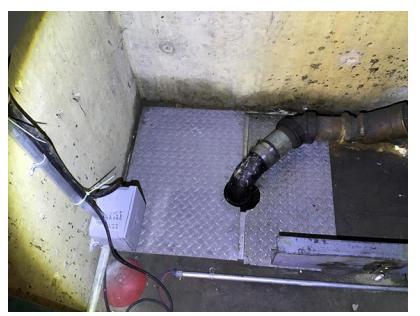
Fig. 10 – Sump
