ELEVATOR MODERNIZATION REPORT

CLATSOP COUNTY, OR

FOUR (4) ELEVATORS

5/26/2021

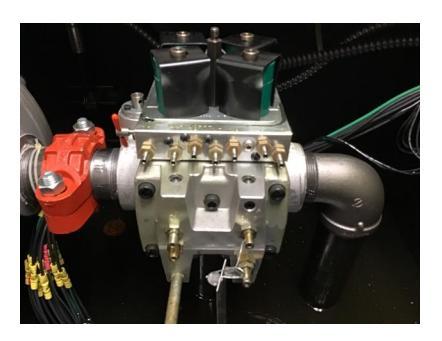
Fig. 1 – Controller

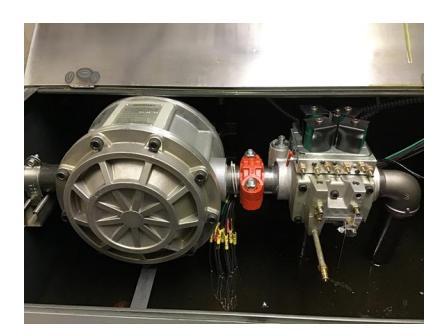
Fig. 2 – Valve

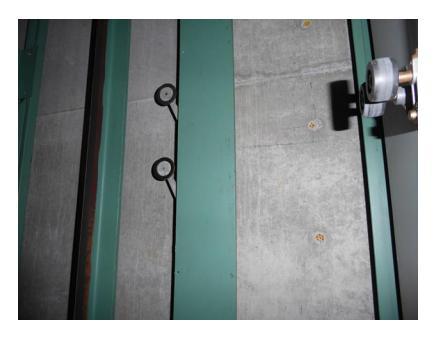
Fig. 5 – Car top
